TRANSMISSION THERMAL MAPPING (CH-47C
FORWARD ROTOR TRANSMISSION)

Boeing Vertol Company

3. REPORT TITLE TRANSMISSION THERMAL MAPPING (CH-47C FORWARD ROTOR TRANSMISSION)		
4. DESCRIPTIVE NOTES (Type of report and inclusive dates) Test and Demonstration Report (Final Report)

5. AUTHOR(S) (First name, middle initial, last name) Rocco C. Tocci A. J. Lemanski Nelson J. Ayoub		
6. REPORT DATE May 1973	7a. TOTAL NO. OF PAGES 167	7b. NO. OF REFS
8a. CONTRACT OR GRANT NO. DAAJ02-72-C-0075	8a. ORIGINATOR'S REPORT NUMBER(S) USAAMRDL Technical Report 73-24

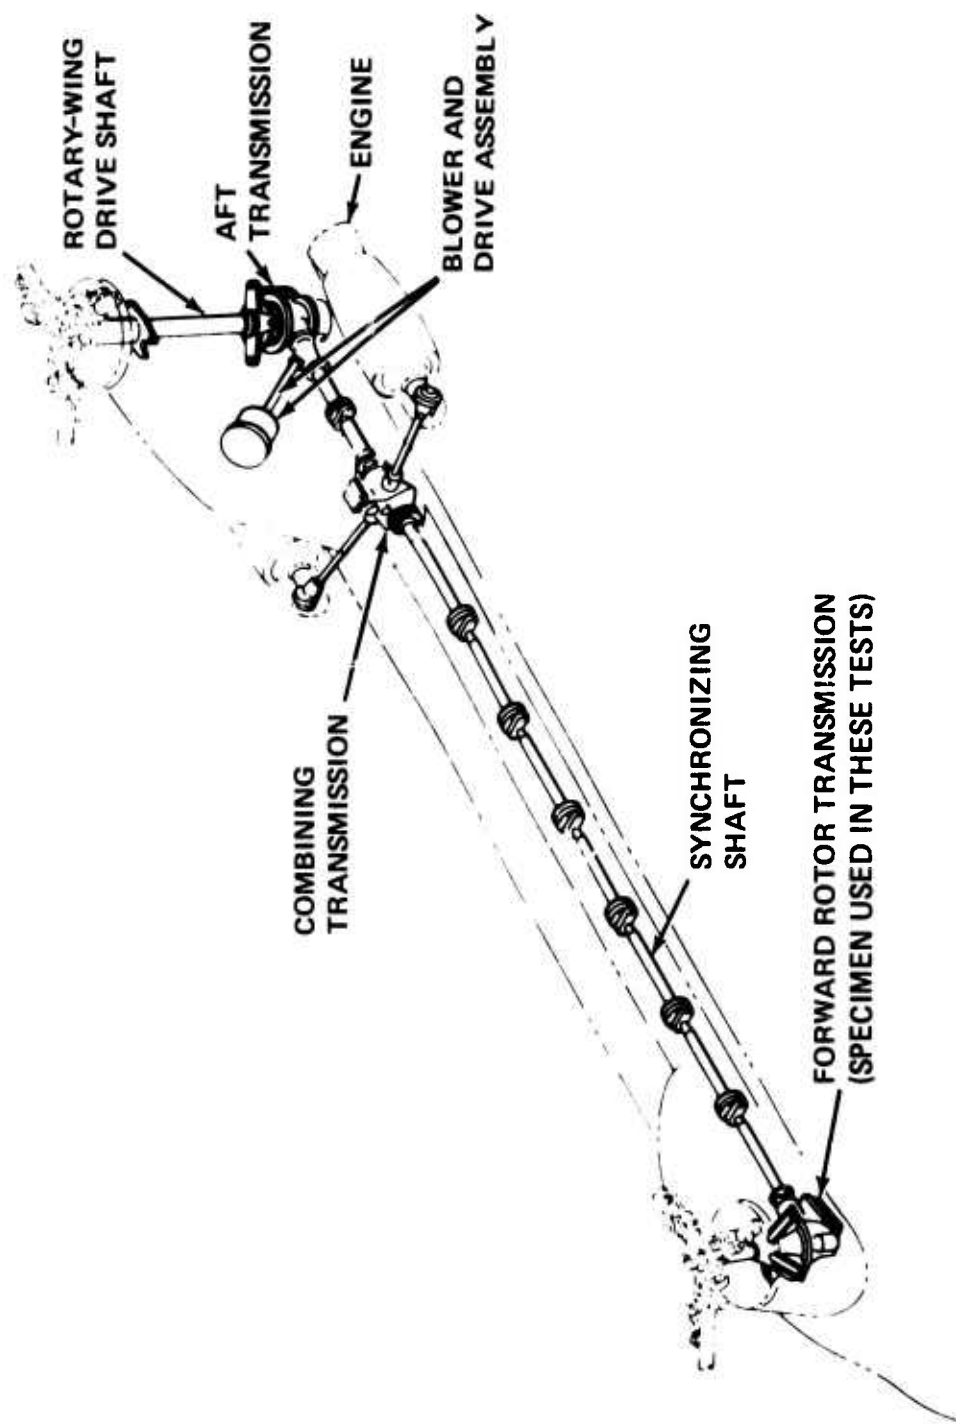
Figure 1. CH-47C Helicopter Drive System.

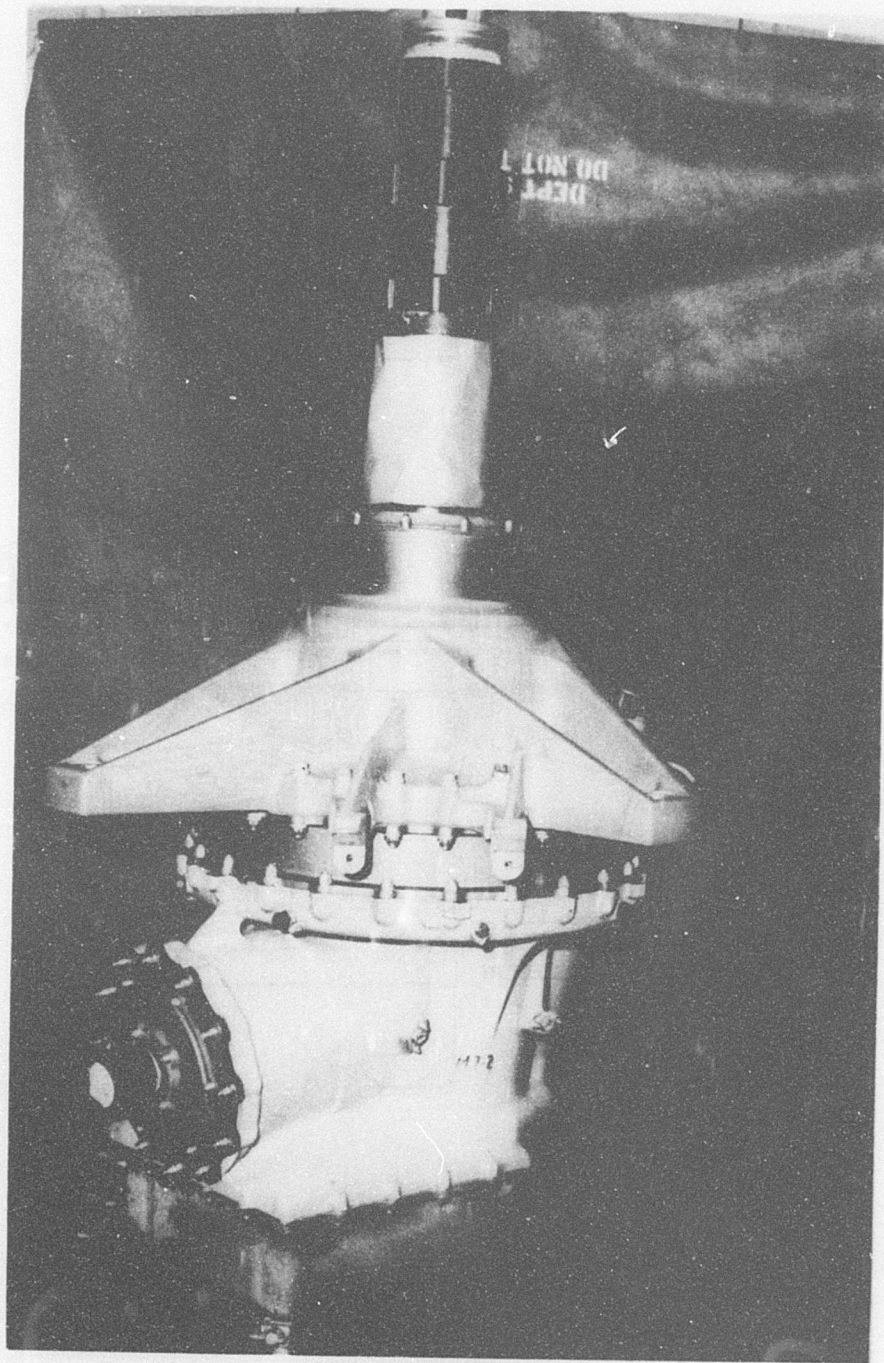
Figure 2. CH-47 Forward Rotor Transmission.

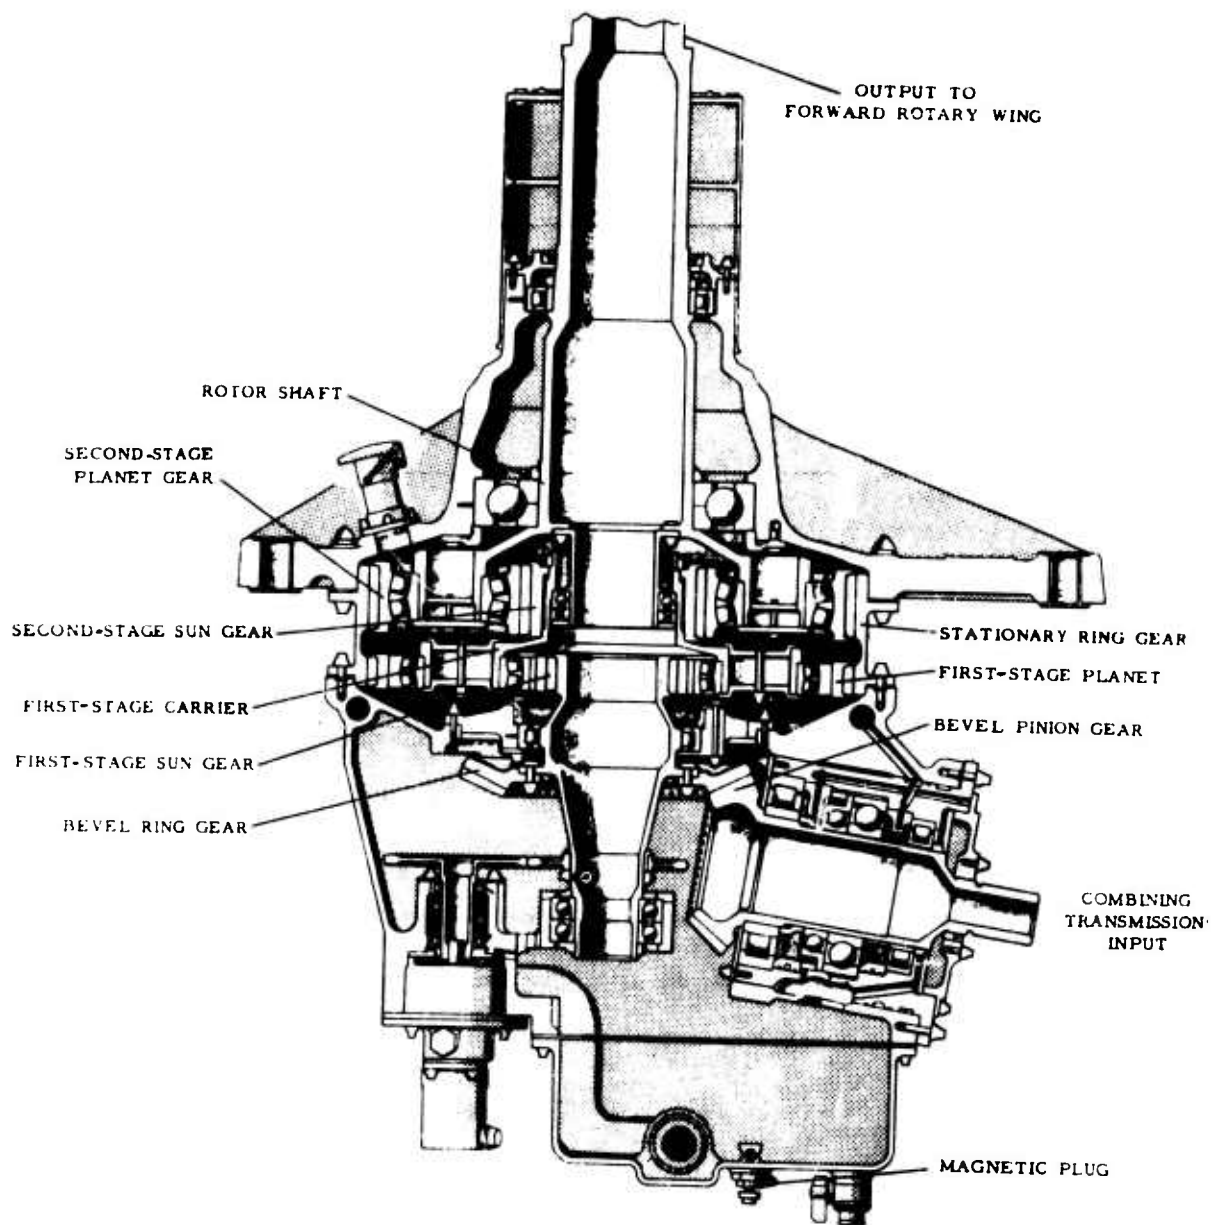
Figure 3. Sectional View of CH-47 Forward Transmission.

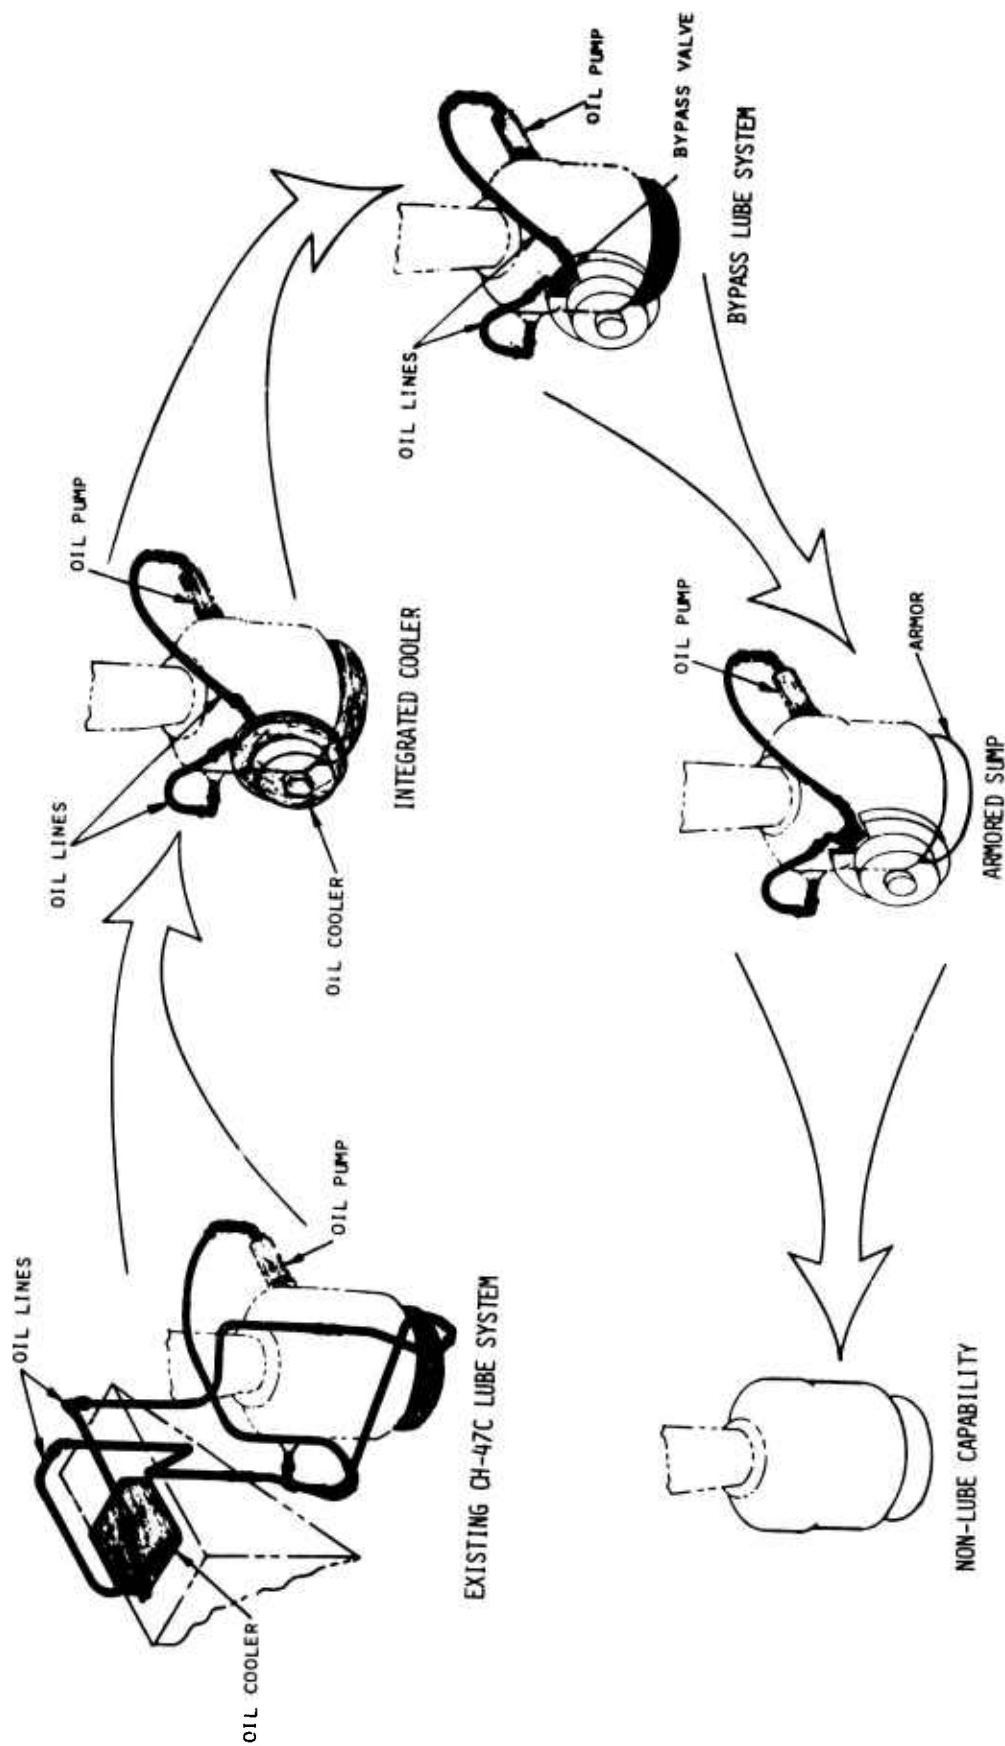
Figure 4. Sequence of Development Required to Arrive at a Lubricant Integral Sealed Transmission.

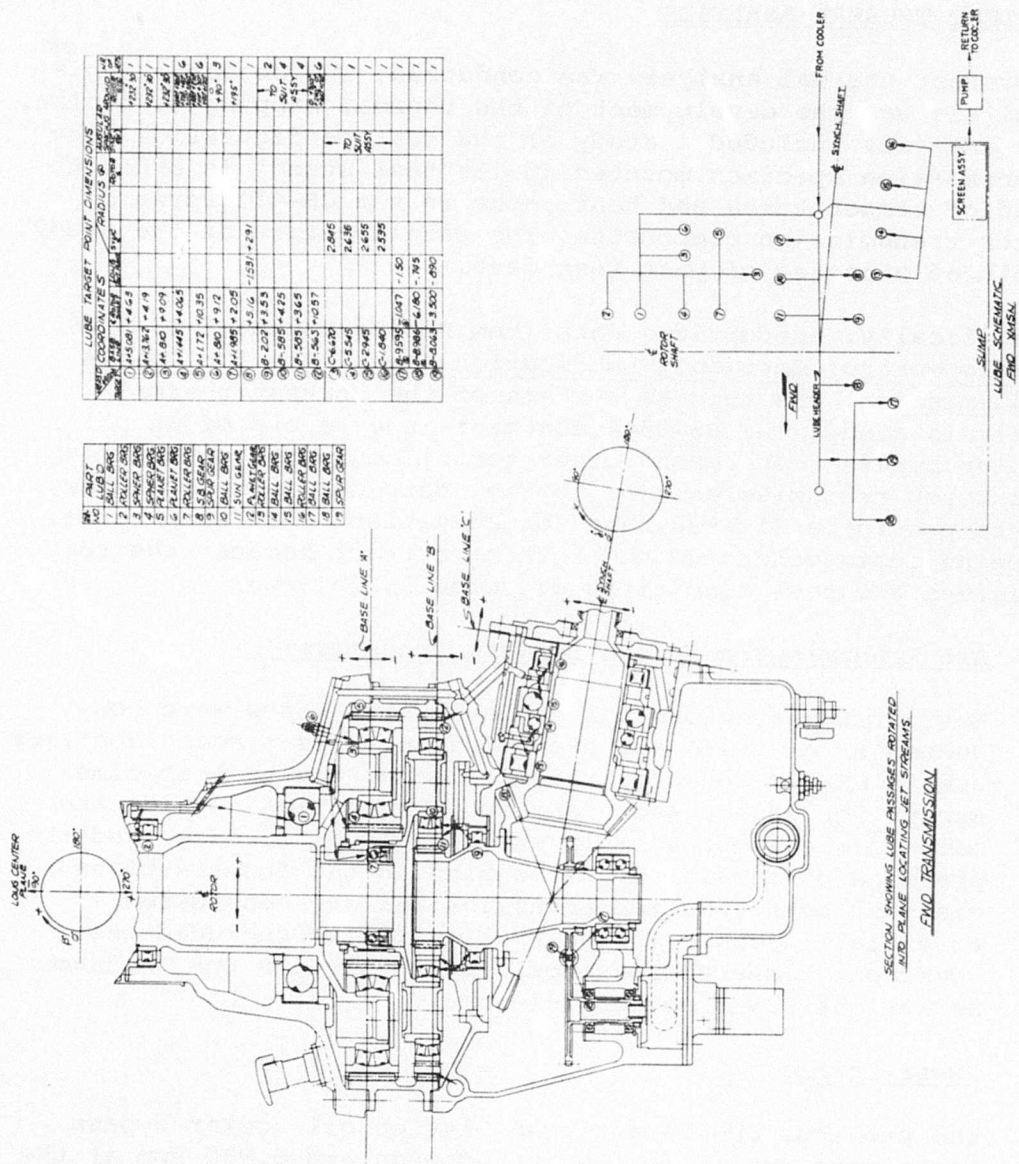
Figure 5. Schematic Lube Diagram of CH-47 Transmission.

necessary interconnecting lines, filters and valves. The pump draws oil from its respective sump, pressurizes it, and sends it through external lines to the cooler, from which it flows to the transmission jets. These jets meter the oil and direct it into the gears and bearings. The oil then drains by gravity to the sump and is recirculated by the pump. Figure 4 illustrates a typical sequence of development required to arrive at a lubricant-integral sealed transmission. Figure 5 is a schematic drawing of the CH-47 forward transmission lubrication system.

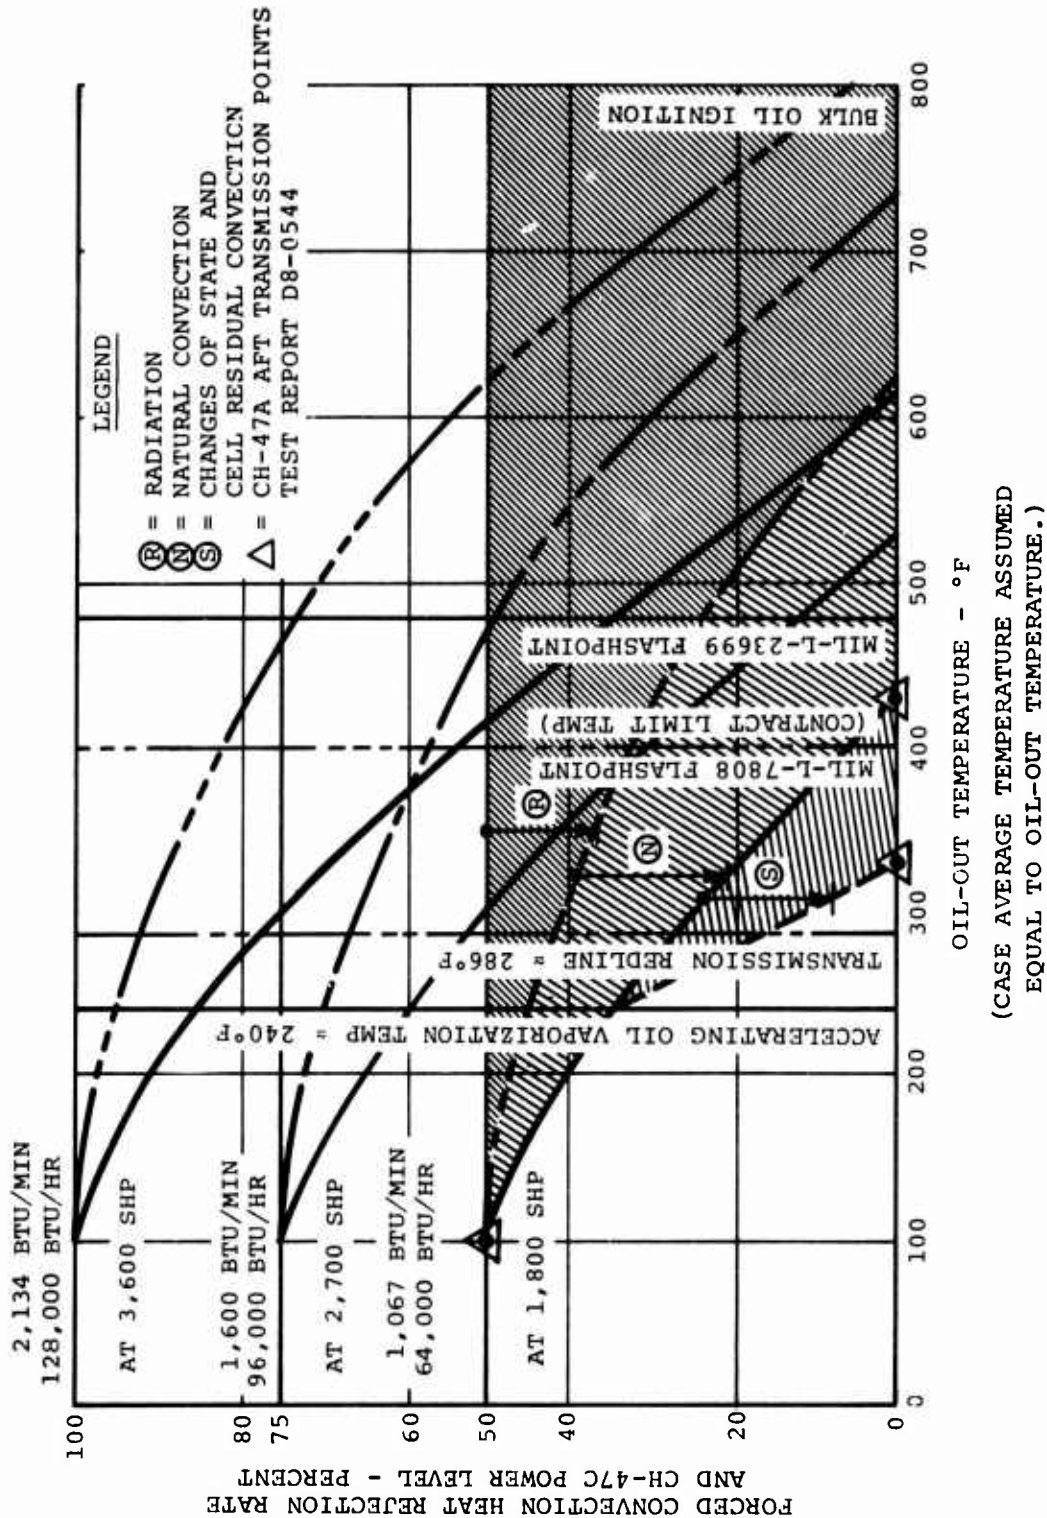
Figure 6. Theoretical Temperature Projection for Given Heat Rejection Rates and Power Levels (Based on CH-47 Forward Transmission Efficiency of 98.6 Percent).

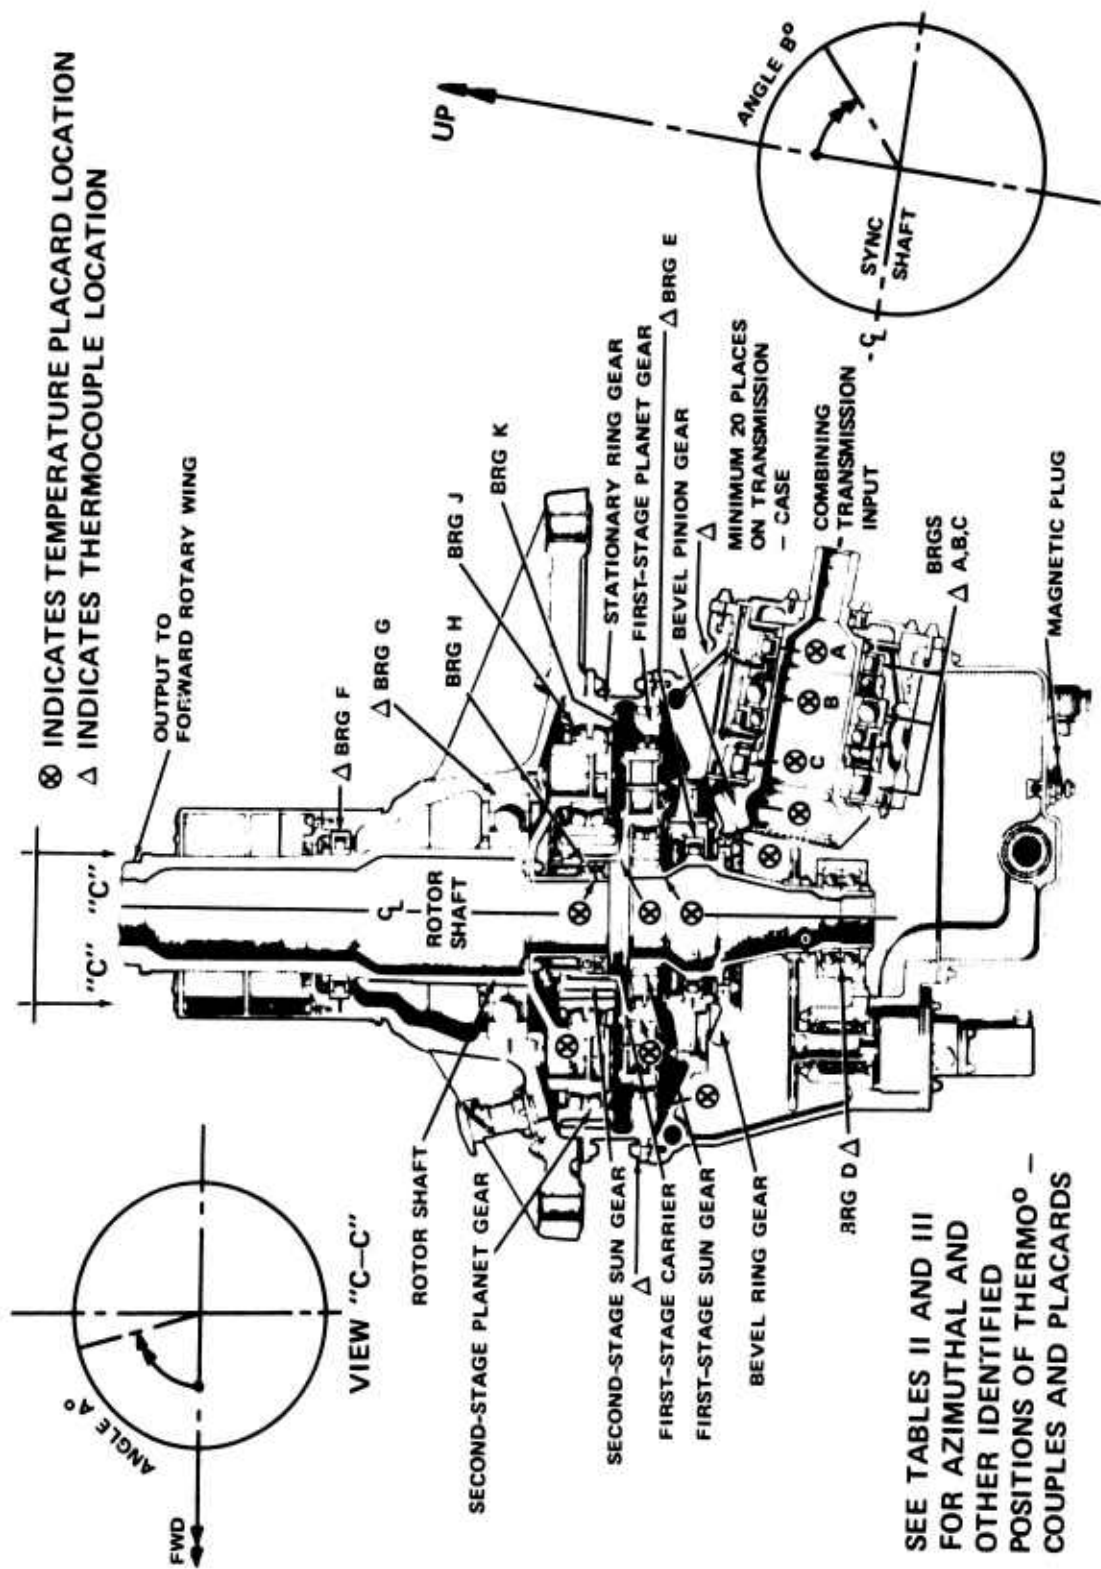
Figure 7. Test Plan Thermocouple and Temperature Placard Positions.

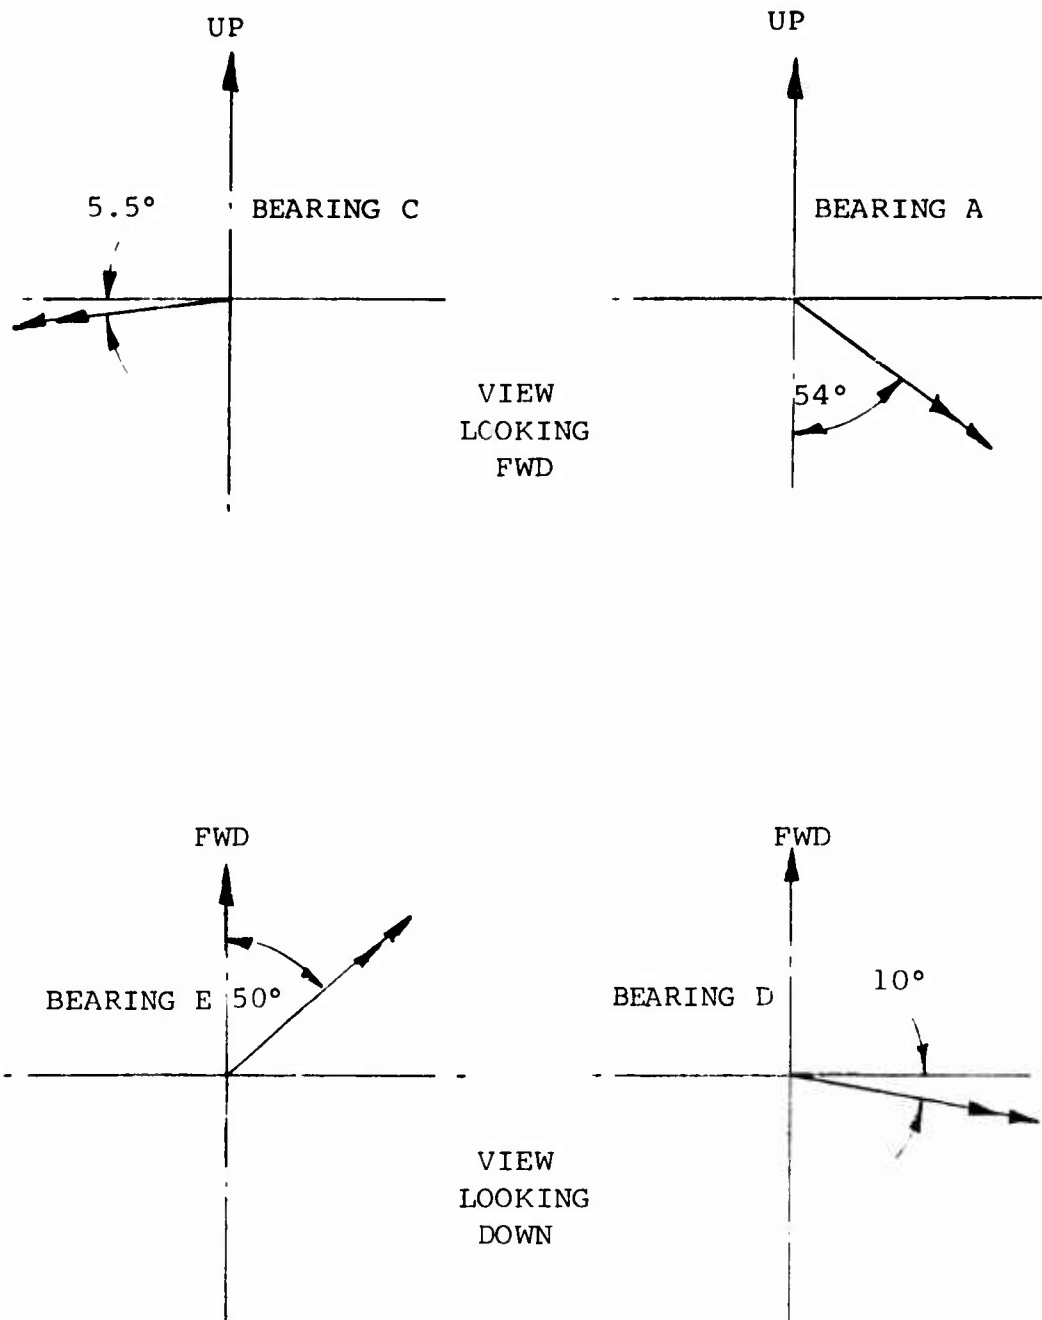
Figure 8. Maximum Load Vectors of Bearings A, C, D, and E.

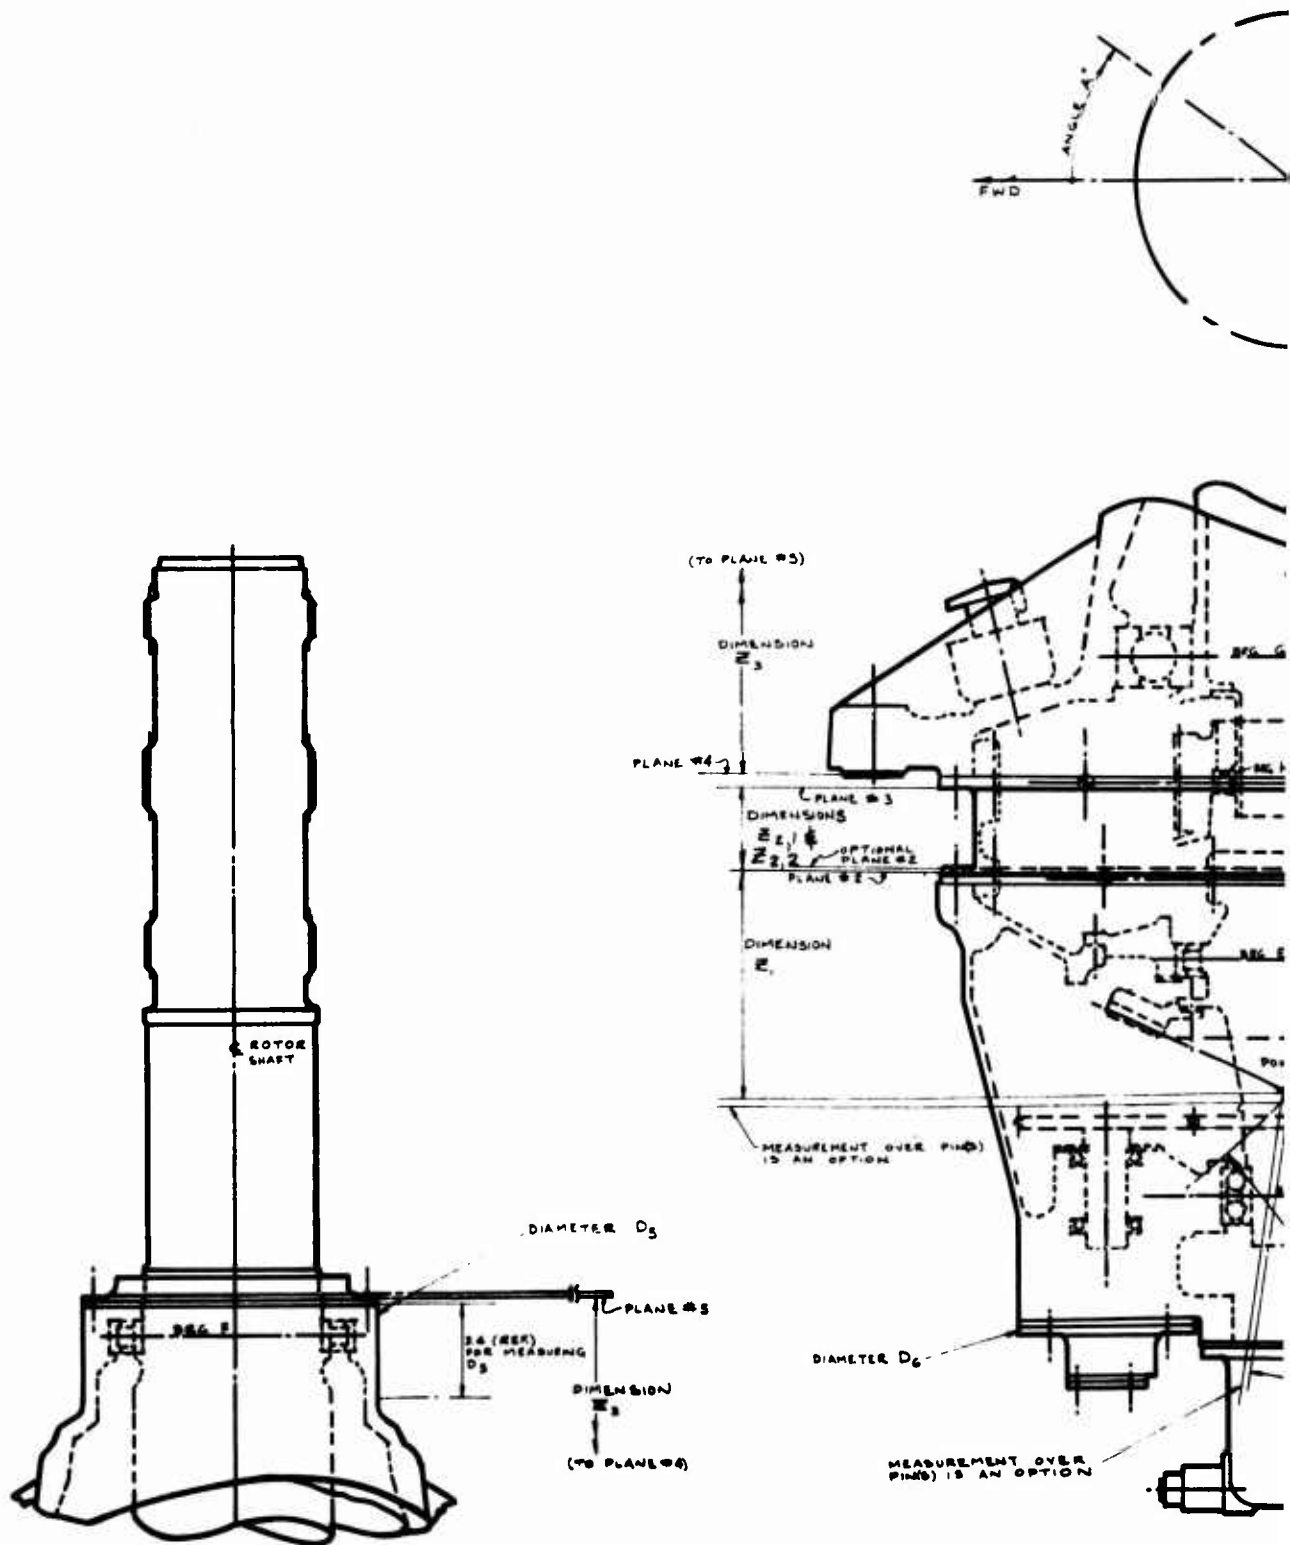
Figure 9. CH-47C Forward Transmission Thermal Growth Dimensions Drawing.

TABLE IV. MEASUREMENTS OF THERMAL GROWTHS (Case Elements)	
DIMENSIONS OR DIAMETERS*	LOCATIONS*
D1 (Dia.)	Around Planetary Stages
D2 (Dia.)	
D3 (Dia.)	
D4 (Dia.)	
D5 (Dia.)	Rotor Shaft Radial Bearing Housing
D6 (Dia.)	Pump Housing
D7 (Dia.)	Sync Shaft
D8 (Dia.)	
D9 (Dia.)	Sync Shaft Coupling
X1 (Dim.)	Point thru Rib at Cone \varnothing S/B and \varnothing Shaft at D7 Diameter
X2 (Dim.)	Diagonal: \varnothing S/B Cone and Sump Flange at Bearing C
X3 (Dim.)	Between B and C Bearings on \varnothing Shaft and Cone \varnothing S/B
Z1 (Dim.)	S/B Cone Center and Plane 2
Z2, 1 (Dim.)	Outer Points
Z2, 2 (Dim.)	Inner Points
Z3 (Dim.)	Between Planes 4 and 5
*See Figure 9

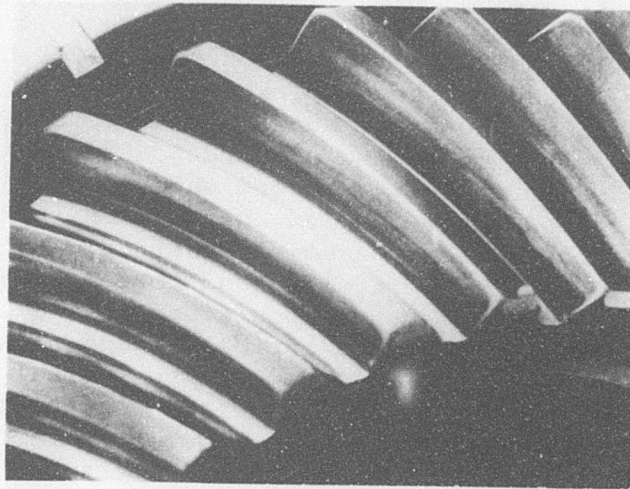
Figure 10. Postinspection Photograph of Spiral Bevel Pinion and Gear.

Figures 10, 11 and 12 are inspection records of the acceptable condition of the spiral bevel pinion and gear, first-stage sun and planet, and second-stage sun and planet, respectively. Figure 13 shows the machining preparation for Thermocouple 2 (Bearing E). Figure 14 is a record which shows several seal-type spring-loaded thermocouples in position in the lower case (with spiral bevel gear subassembly omitted). Figures 15, 16, and 17 are right side, left side, and bottom side records of thermocouple and/or receptacle positions on the lower case, respectively. Figure 18 is a typical record of a trammel detent marking (the position shown is the spiral bevel gear cone center projected to the outside web on the lower case used to measure thermal growth). Figures 19 through 26 give a photographic record of the temperature placards and/or thermocouple backup for the spiral bevel pinion and gear; first-stage sun, planet, and planet carrier arm; and second-stage sun, planet, and planet carrier arm; respectively. Figure 27 is a record of the spiral bevel pinion cartridge in a modified state to accept thermocouples and bearings A, B, and C outer-race drag-torque locking key machining/assembly. Figure 28 shows the spiral bevel pinion and gear (with first-stage sun) in a subassembly state (the locking keyways on bearings A, B, and C can be seen in Figure 27). Figures 29 through 32 are records of the assembled modified specimen transmission (with thermocouple leads attached) prior to installation in the test stand. The order presented represents the forward, right, aft, and left sides, respectively.

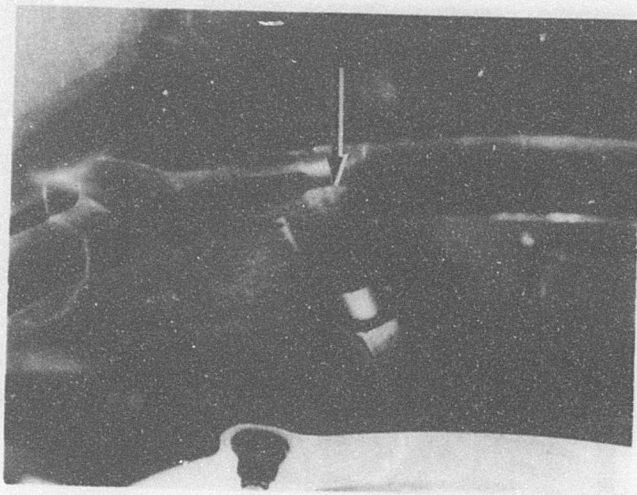
Figure 13. Machining Preparation for Thermocouple 2 (Bearing E).

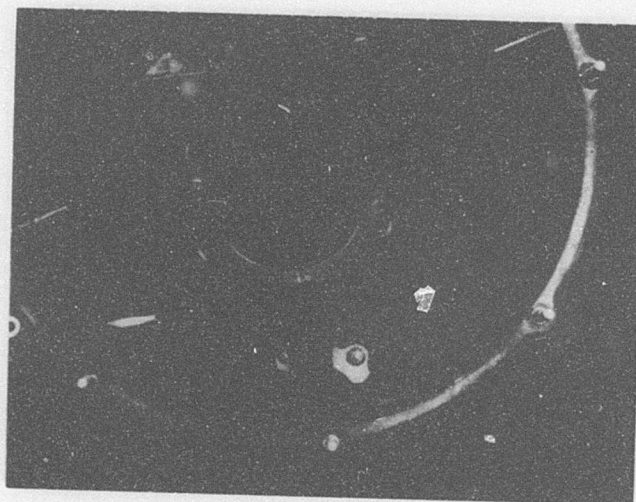
Figure 14. Several Seal-Type Spring-Loaded Thermocouples in Position in Lower Case.

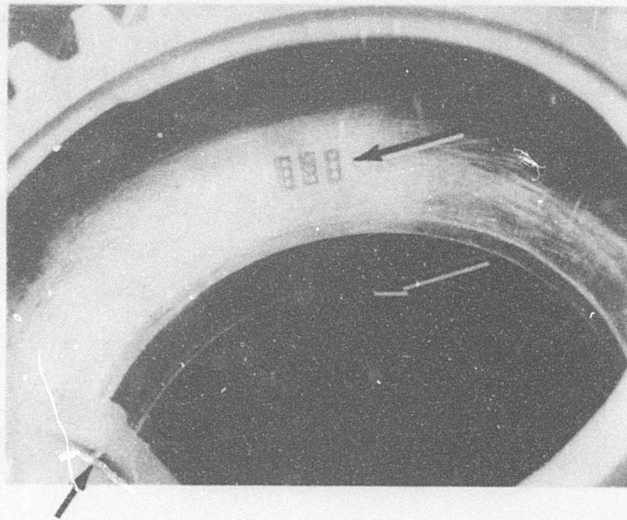
Figure 19. Temperature Placards and Thermocouple Backup of Transmission Gear Elements.

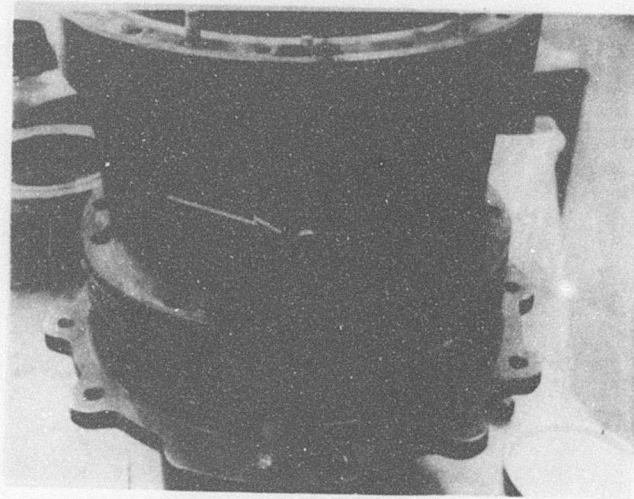
Figure 27. Modified Spiral Bevel Pinion Cartridge.

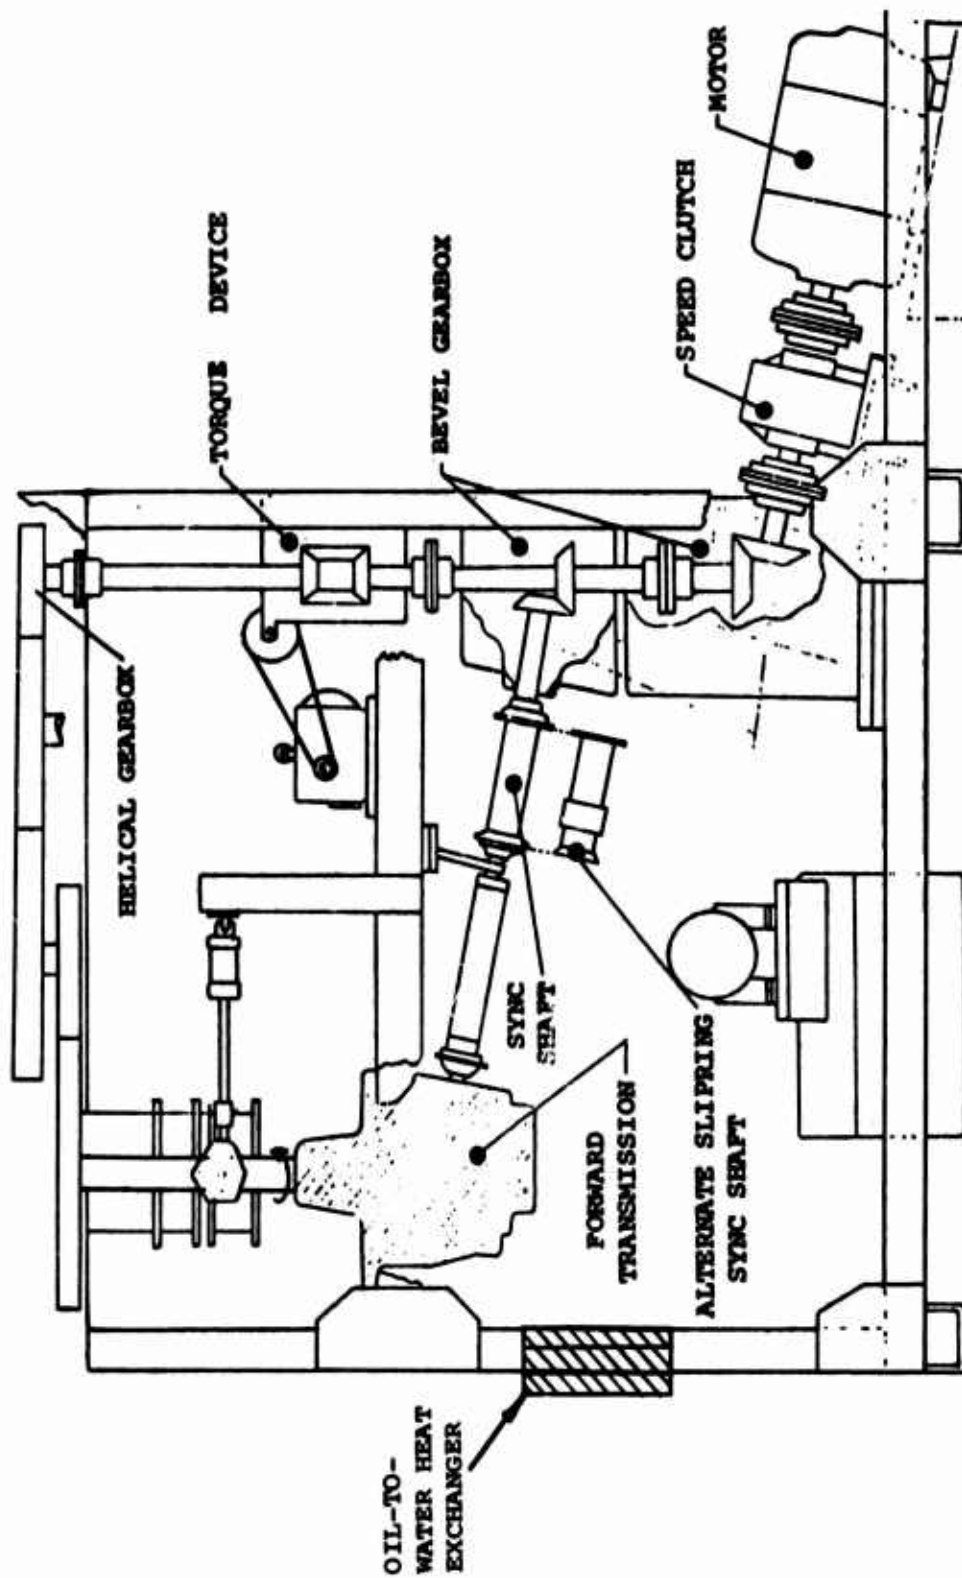
Figure 33. Schematic Diagram of Closed-Loop Test Stand.

Figure 33 is a schematic diagram of the subsystems making up the closed-loop test stand. Figures 34 through 37 show the specimen instrumented transmission mounted in the test stand. The respective figures in order are: fwd (oblique), right-aft (oblique), left-aft (oblique), and top-aft views. These photographs show the specimen with the thermal instrumentation hookups as well as the lubrication lines leading to the console located outside the test cell. Figure 38 is a photograph of the test monitoring units. The heat exchanger water-flow control valve modification (for control of oil inlet and oil outlet temperatures) is out of the field of view in Figure 38, but lies on the floor between the cell permanent instrumentation console and the special oscillographic (including backup channel) console for this test on the far right. Behind the oscillographic console, the infrared recording console can be seen. A better view of the infrared temperature recording console is shown in Figure 39 with CRT visor and Polaroid camera mounted to the display unit. Figure 40 shows the infrared sensing and transmitting unit in position in the test cell. It is targeted on the

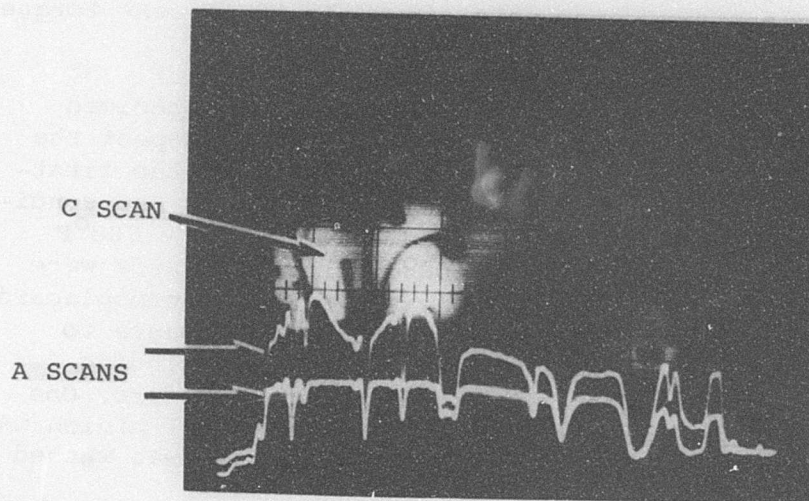
Figure 41. Typical Infrared Data Display.

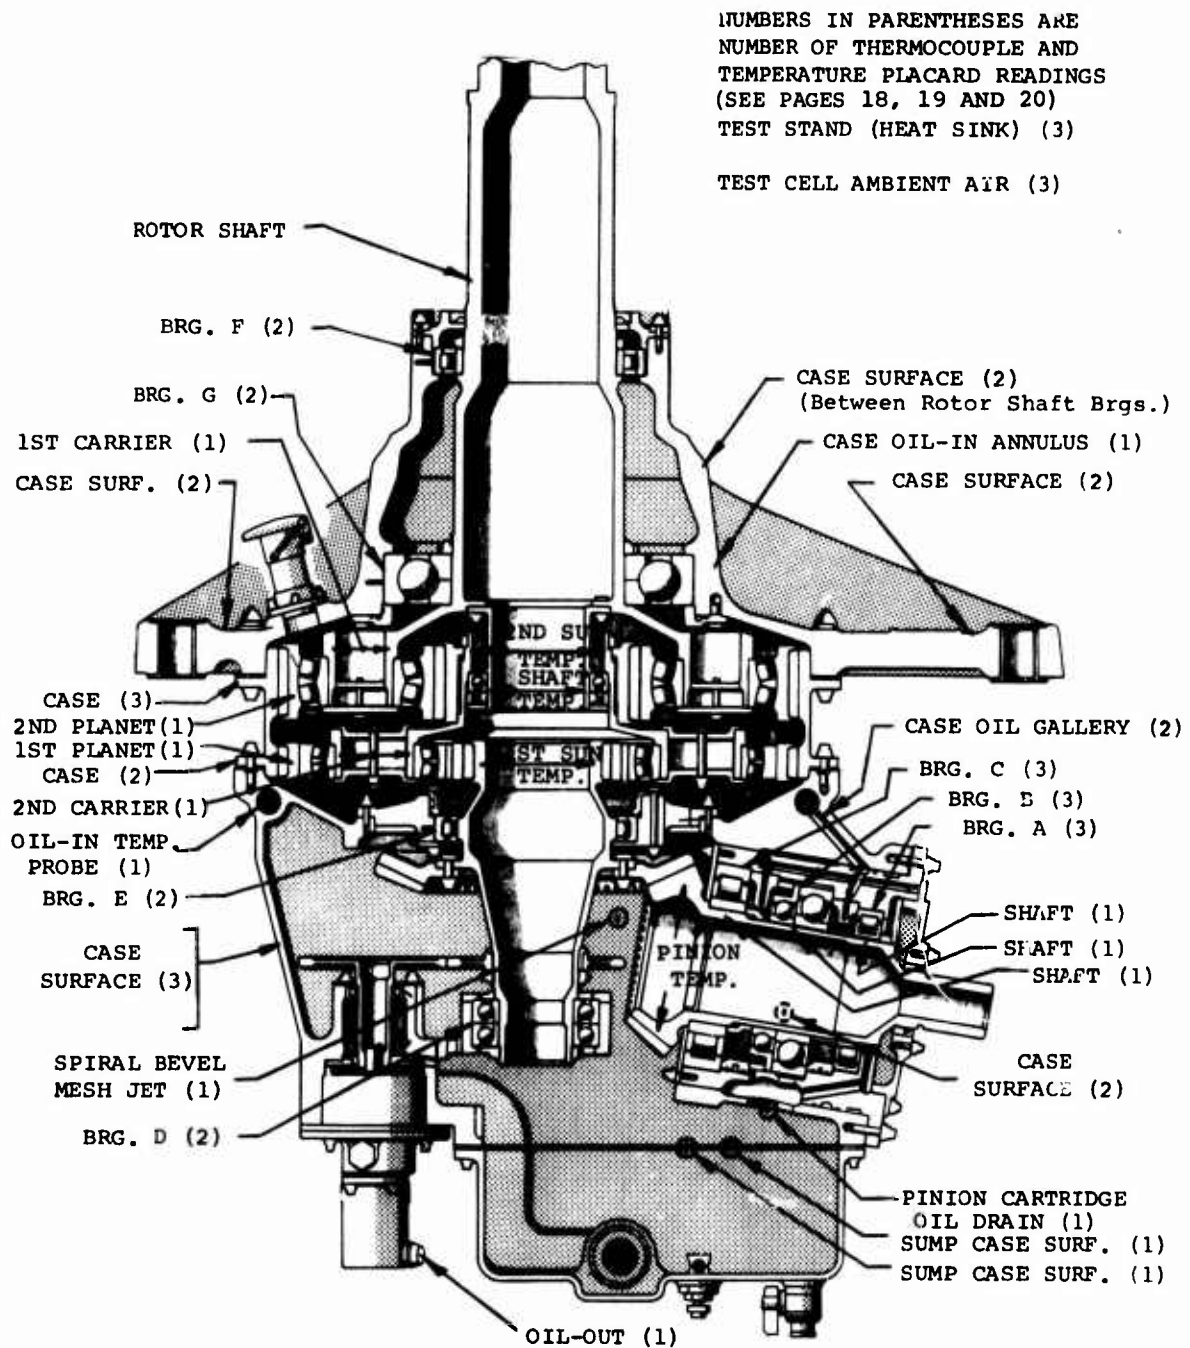
Figure 42. Thermal Mapping Component Temperature Legend.

NOTE: All numbers shown
are temperatures, T, in
degrees Fahrenheit (at
shutdown).

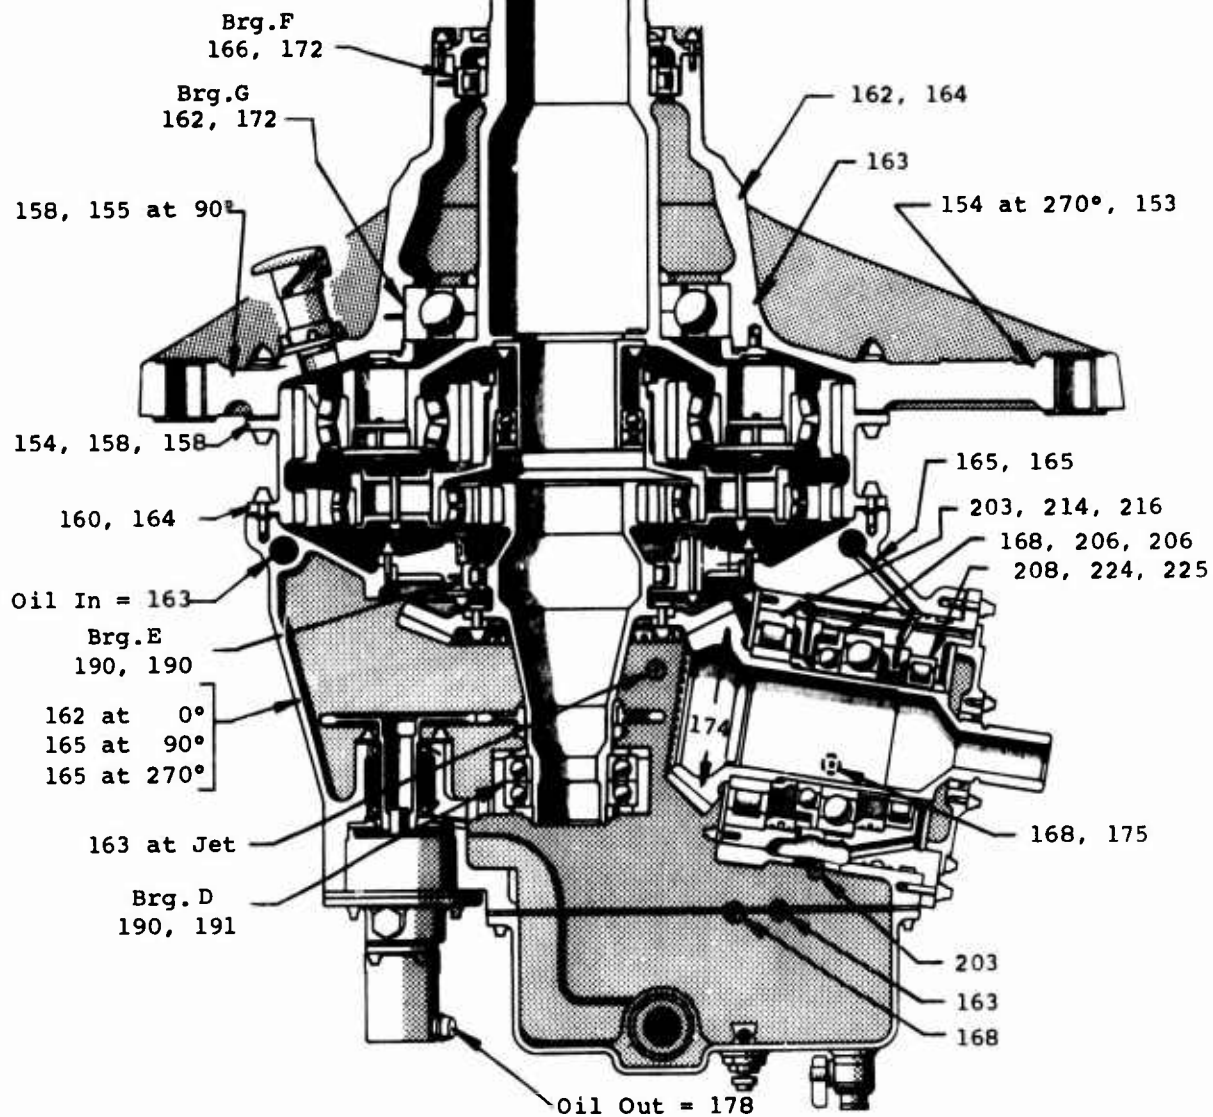
Figure 42. Thermal Map of Test 1 at 10 Percent Torque.
